# CITY OF MISSOULA

## 1992 TRAFFIC SAFETY IMPROVEMENT STUDY

**TRAFFIC SAFETY  
IMPROVEMENT STUDY**

November 1992

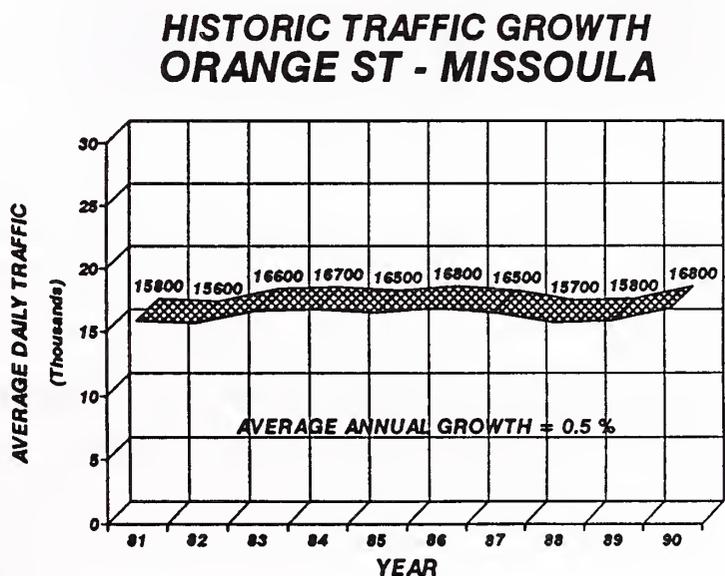
**Figure 2.** illustrates traffic growth on Orange Street during the past nine years. Generally, traffic is growing at an annual of approximately 0.5% per year.

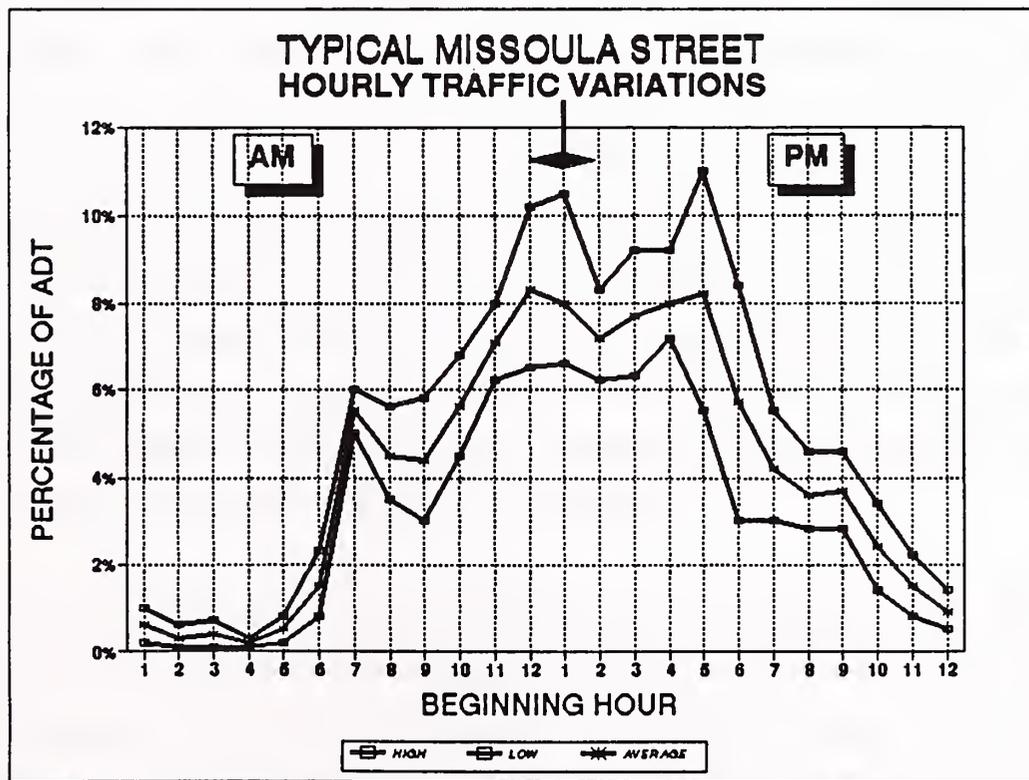
Figure 5., below, presents hourly traffic variations for a range of street types with in Missoula. Ten different count stations at or near the study sites were used to develop the high and low range of hourly variations. As such, Figure 5. only indicates typical hourly variations, with the middle line representing an average. Similar graphs were developed for each street counted and were used to estimate ADT on applicable streets and to predict peak hour volumes for capacity analysis and control device warrants.

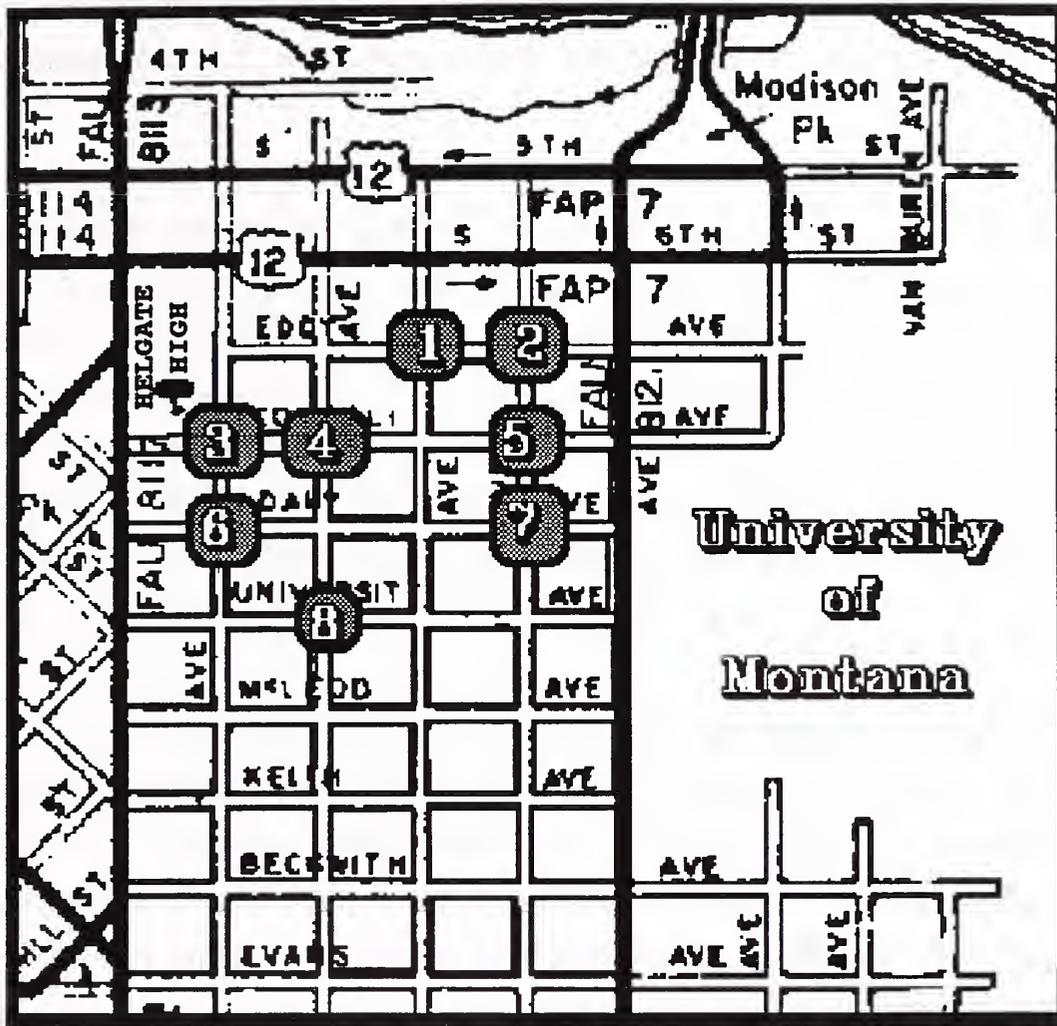
FIGURE 14. CORRIDOR ACCIDENT NUMBERS & LOCATION

Figure 14. illustrates the corridor area. The eight intersections and the number of accidents at each intersection is shown. The intersection of Connell and Helen is included as one of the study sites and has the highest number of accidents (10) and the highest accident rate (8.06). The average accident rate for these 8 intersections is approximately 4.8 accident per million vehicles entering (MVE). This accident rate is approximately five times the accident rate that could be expected at low volume intersections and at least twice the rate of the average for all study sites. However, the estimated traffic volumes were based on observations during the time when neither Helgate High nor the University of Montana were in session. Of the 45 total accidents 36 were angle accidents; 2 were rearend; 1 was a pedestrian; 2 were sideswipes; and 4 involved parked cars. There were 16 persons injured within the eight intersections. The accidents are clustered in the morning, noon and mid-afternoon periods, coincident with school arrivals and departures. The vast majority of accidents also occurred during mid-week.

CORRIDOR SITE NO.	AVENUE	STREET	NUMBER OF ACCIDENTS
1	EDDY	HILDA	6
2	EDDY	HELEN	7
3	CONNELL	GERALD	3
4	CONNELL	RONALD	4
5	CONNELL	HELEN	10
6	DALY	GERALD	7
7	DALY	HELEN	5
8	UNIVERSITY	RONALD	3
TOTAL IN CORRIDOR AREA =			45
AVERAGE PER INTERSECTION =			5.6

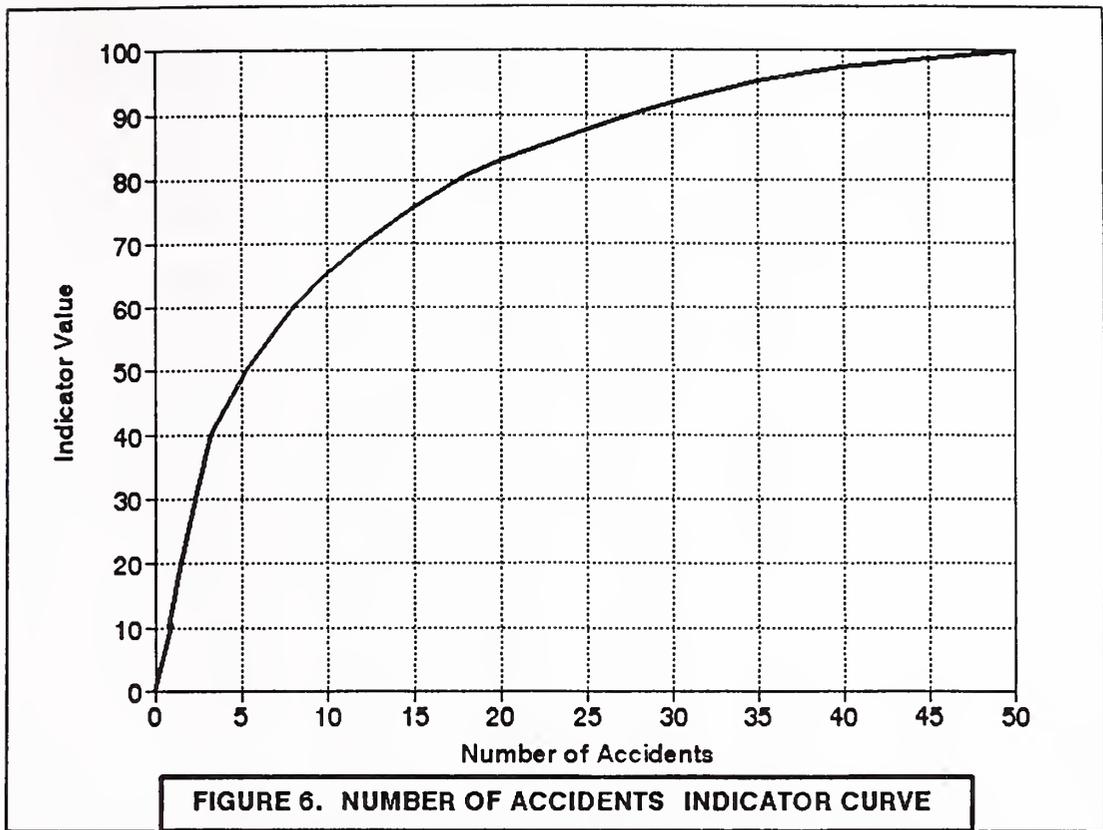
Figure 6. is a curve extracted from the FHWA report which was used to determine the indicator value. The data base is number of accidents per year. This indicator, as with all of the seven indicators used in the report, is scaled between 0 and 100. An average of two accidents per year in a three year period indicates a hazardous location (indicator value of 33). An average of ten accidents per year is used to designate a very hazardous location (indicator value of 67). In the case of this study, the total number of accidents per site criteria was used to extract the index value rather than the annual rate. This higher value is therefore more consistent with the level of the other index values. Using an annual rate would have scaled down the importance of this indicator relative to other index values. Table 3. is the computer generated ranking of all sites based on this indicator. It can be seen that none of the sites exceeded the maximum value of 100 and the average value of 60.3 was in the same range as other hazard index values.
